SERVICE INSTRUCTION AMENDMENT ON REDUCTION GEARBOX TYPE "C" AND TYPE "E" FOR ROTAX_® 2-STROKE UL AIRCRAFT ENGINES SI-06-1998

Amendment on reduction gearbox type "C" and type "E" for 2-stroke UL aircraft engines.

JULY 2001 Rev.1

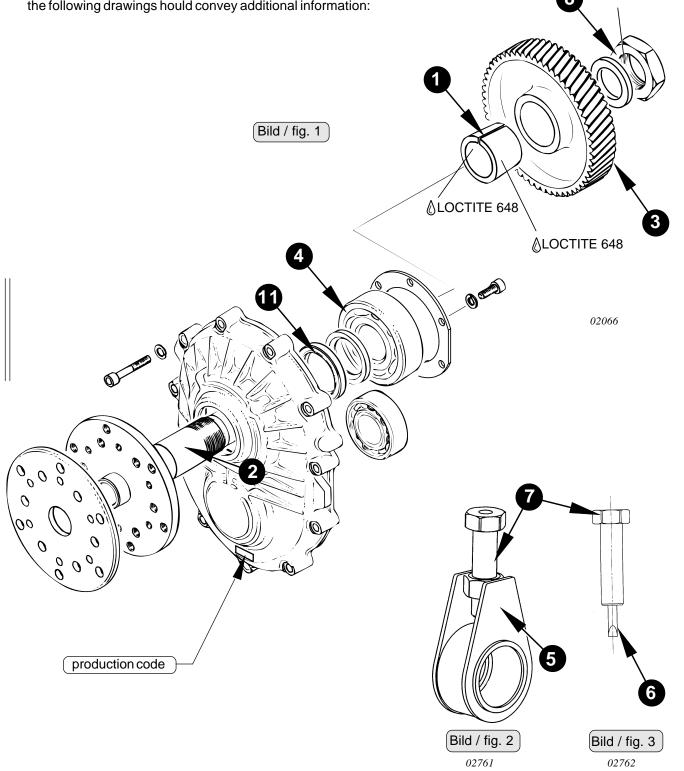
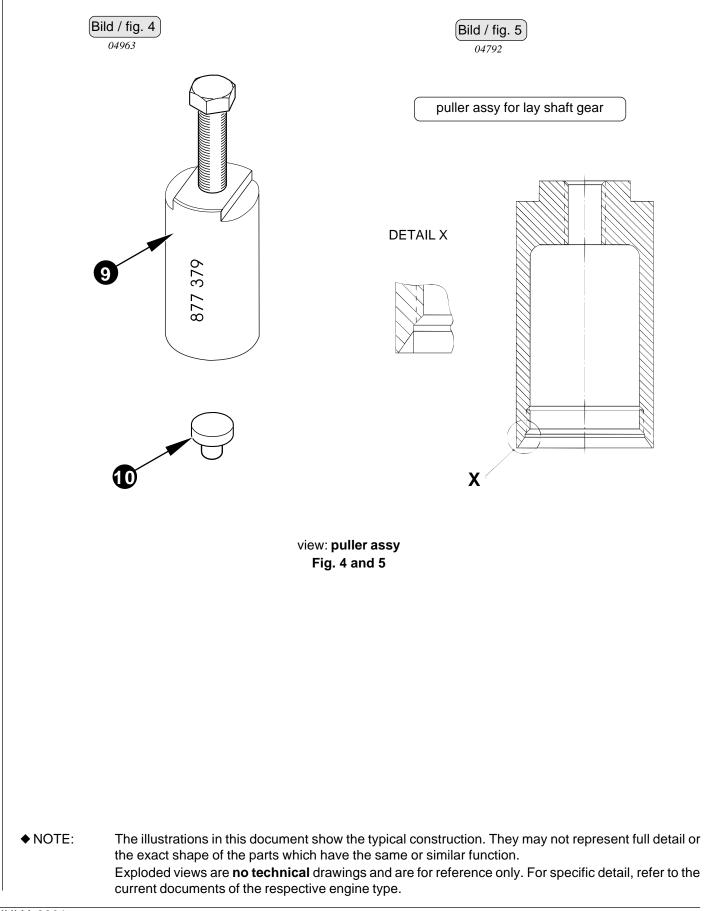
view: installation sleeve assy / C-gearbox Fig. 1, 2 and 3

Gluing-in of the cone sleeve will reduce the tightening torque of the hex. nut.

Introduction of an installation sleeve to facilitate fitting of the cone sleeve.

- Disassemble the reduction gearbox in accordance with the current Repair Manual for engine type 462-532-582 to a state where the cone sleeve (1) can be removed.
- Clean and degrease cone sleeve (1).
- Degrease propeller shaft (2) and lay shaft gear (3).

- Place cone sleeve (1) into installation sleeve assy (5). Make sure that the rotating shaft (6) of the pressure screw (7) comes to rest in the slot of the cone sleeve (1).

- Using a spanner move shaft (6) into slot until the cone sleeve (1) expands enough.
- CAUTION: But ensure that the shaft will not move beyond inside dia. of the sleeve. Otherwise you risk damage to the propeller shaft.

- Apply LOCTITE 648 on inside of cone sleeve (1).
- ▲ WARNING: Make absolutely sure that no LOCTITE will enter into the ball bearing (4).
- After placing cone sleeve (1) into position on propeller shaft slacken the pressure screw (7) and remove the tool.

- Apply LOCTITE 648 on outside of cone sleeve (1).
- The tightening torque of the hex. nut (8) has been newly specified to 250 ±10 Nm (185 ±7 ft.lb).
- Reassemble reduction gearbox in accordance with the current Repair Manual for engine type 462-532-582.
