SERVICE INSTRUCTION

RUNNING MODIFICATIONS ON ROTAX_® 2-STROKE UL AIRCRAFT ENGINES <u>SI-2ST-004</u>

Running modifications on ROTAX_® 2-stroke UL aircraft engines.

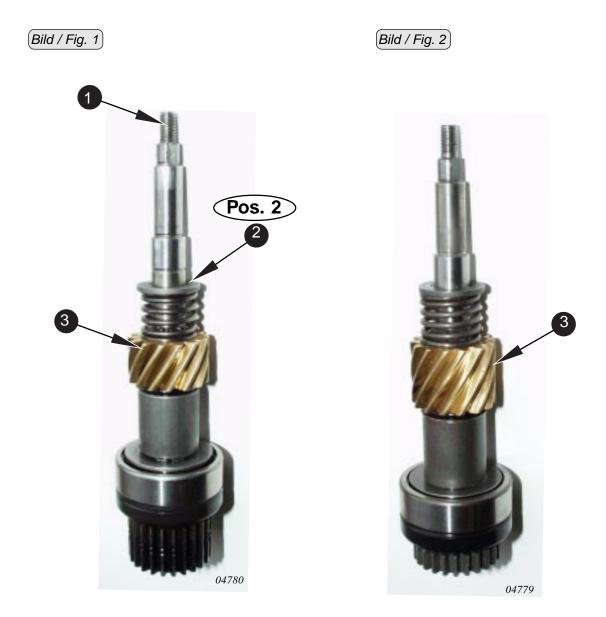
View: Rotary valve drive 582 UL Fig.: 1and 2

By reason of standardization a new rotary valve shaft unit has been introduced on the 582 UL mod. 99. The new rotary valve shaft (1) part no. 837 243 has two grooves for fixing the rotary valve shaft components.

- CAUTION: At assembly of the rotary valve shaft components make sure to fit circlip (2) part no. 845 160 in the second groove of the rotary valve shaft (thus reaching a higher pretension on the rotary valve (3)). In the first groove, utilized on other engine types, no circlip shall be fitted!
- ♦ NOTE: For assembly details of the rotary valve shaft consult the relevant Illustrated Parts Catalog.
