Gearbox fixation on UL-engines type 377, 447, 462, 503 and 532

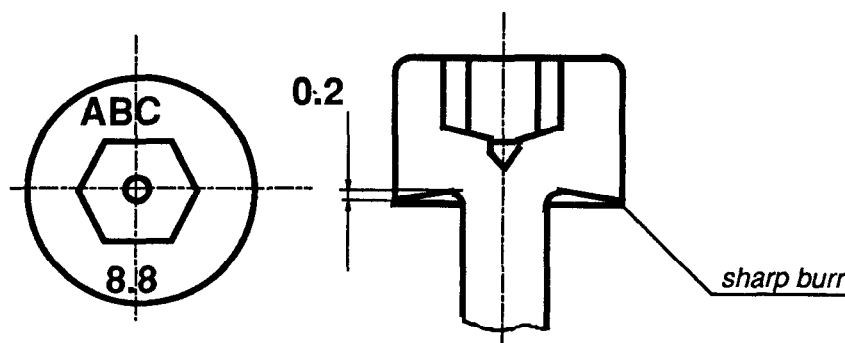
In isolated cases, where heavy propellers were used, screw heads forced into the adapter flange and loosened it.

- a) Screw head contact surface is tapered by 0,2 mm.
Only the outer edge of the screw head is contacting the flange, slackening the screw fit by vibrations.

Before and after every flight check for loosening by visual inspection for any fretting or black aluminium dust at the contact surfaces. If necessary remove gear-box.

- A: Depending on screws mounted:
- Scrap "ABC" screws and order new screws (part no. : see item 1)
 - Rework screws showing indents and or burrs, or order new screws.
- B: Clean all contact surfaces and the bosses on crankcase carefully.

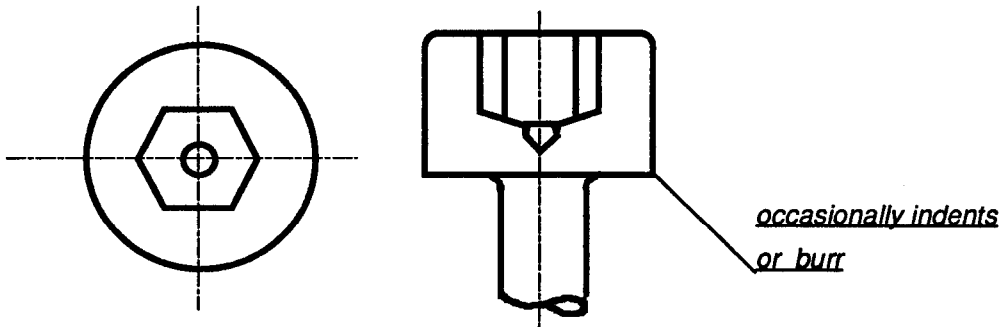
b) If the plane surface has been damaged (knock marks, grooves), screws may slacken.
