ROTAX. SERVICE INFORMATION

8 UL 91-E

Safety - check of the BING - carburetors used in all ROTAX UL - engines

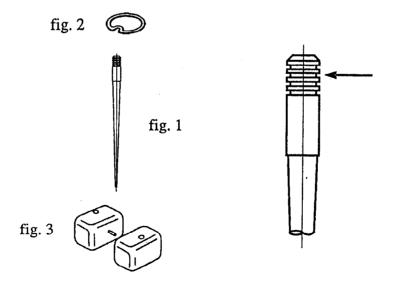
- 2.1) Check jet needle (fig. 1) and needle clip (fig. 2) for wear. If you can detect any wear in the ring groove of the jet needle (see arrow) renew both parts immediately.
- 2.2) Float (fig. 3): Formerly the float had a aluminium-tube-guide which was flanged on both ends. If the material of the floats is broken at the guide tube or if guide is worn, exchange both floats. Carb jets might be blocked.

The aluminium-tube-guide was replaced by a not flanged brass-guide with better sliding-quality. Make the check on floats with brass-guide too.

Carry out check according to item 2 every 50 hours of operation. (See Maintenance plan SI 3 UL 91 - E)
