Ignition unit of ROTAX engine 912 UL

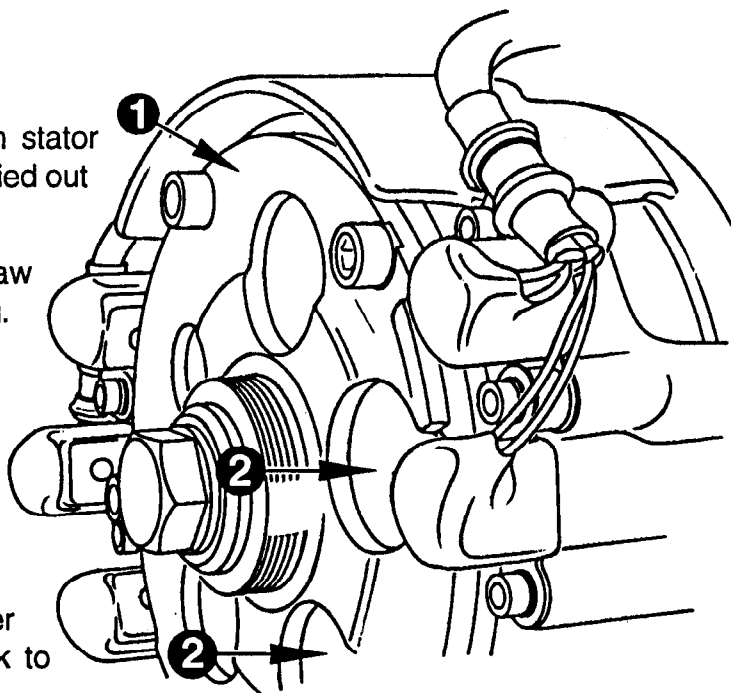
As known from experience, inadequate ground connection could arise between stator and ignition housing on the engine type 912 UL.

Disconnect battery. No need to withdraw magneto housing ❶ with magneto ring. Remove at least 2 of the 4 Allen screws ❸ and lock washers for stator attachment via the openings ❷ in the magneto housing.

■ **ATTENTION:** Make absolutely sure that no foreign matter (lock washer or screws) will stick to the magneto ring.
