# **SERVICE INSTRUCTION**

# LUBRICATION SYSTEM FOR ALL ROTAX<sub>®</sub> ENGINE TYPE 912 (SERIES) AND 914 (SERIES) <u>SI-912-005</u> <u>SI-914-007</u>

Lubrication system for all ROTAX $_{\scriptscriptstyle \otimes}$  engines of the type 912 and 914.

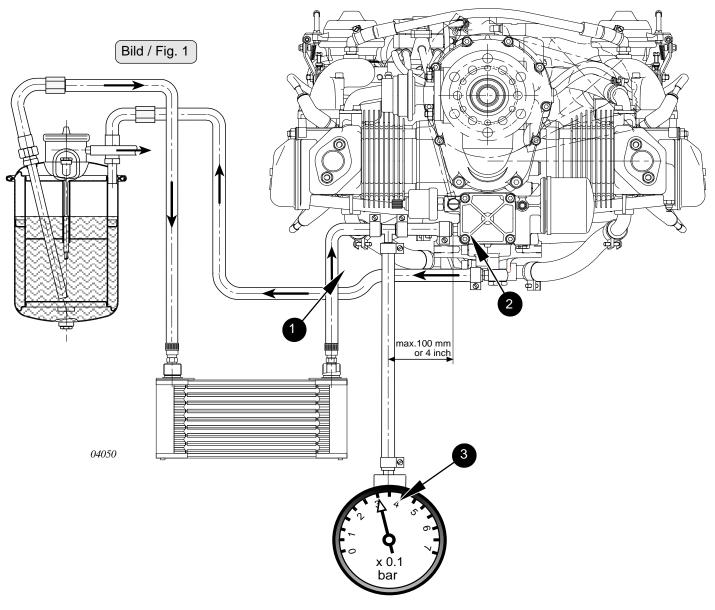
4.1) Measuring of the depression in the oil suction line

Measuring of depression in the oil suction line (1) (line from oil tank to oil pump via oil cooler) at a max. distance of 100 mm (4 in) from pump inlet (2).

At take-off performance the indicated vacuum (3) must not be more than 0,3 bar (4,35 psi or 8,86 in Hg) otherwise the oil hose (1) could crimp and thus blocking the oil supply to the engine (fig 1).

max. 0,3 bar Unterdruck max. 0,3 bar below atmospheric pressure

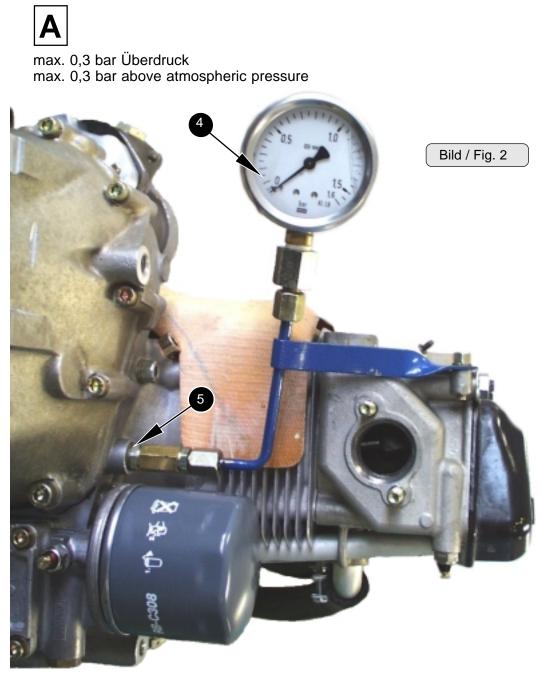
Measure of the mean crankcase pressure at full load (blow-by gas pressure) responsible for proper oil return from crankcase to oil tank. A pressure indicator (4) (pressure gauge with incorporated viscous damper) may be fitted instead of the magnetic plug (5) (see fig. 2).

The pressure in the crankcase at full load must not exceed the prevailing ambient pressure by more than 0,3 bar (4,35 psi or 8,86 in Hg).
