SERVICE INSTRUCTION

RUNNING MODIFICATIONS ON ROTAX_® 2-STROKE UL AIRCRAFT ENGINES <u>SI-2ST-004</u>

Running modifications on ROTAX_® 2-stroke UL aircraft engines.

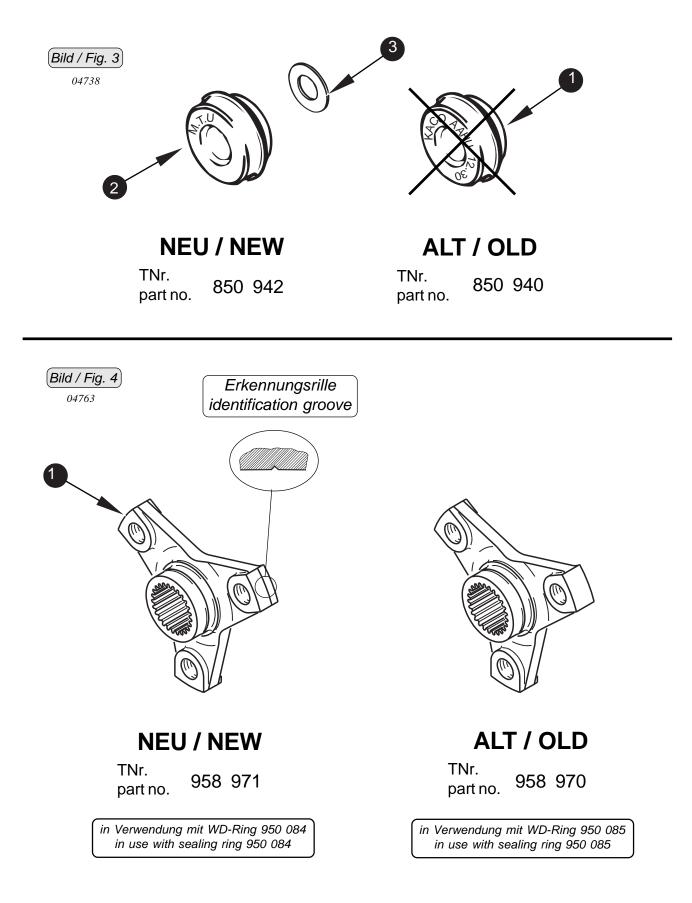
View: Rotary valve drive 582 UL Fig.: 1and 2

Owing to further development and standardization of parts the rotary valve seal (1) part no. 850 940 has been replaced by the rotary valve seal (2) part no. 850 942 along with an additional shim (3) part no. 944 382.
